**SITE ASSESSMENT REPORT
FOR
ORBITRON
DELPHOS, ALLEN COUNTY, OHIO
TDD: T05-9407-003
PAN: EOH1042SAA
DOCUMENT CONTROL NUMBER: TAT-05-23-04023**

AUGUST 15, 1994

Gail Nabasny
Deputy Project Officer
Emergency Support Section
U.S. EPA - Region V

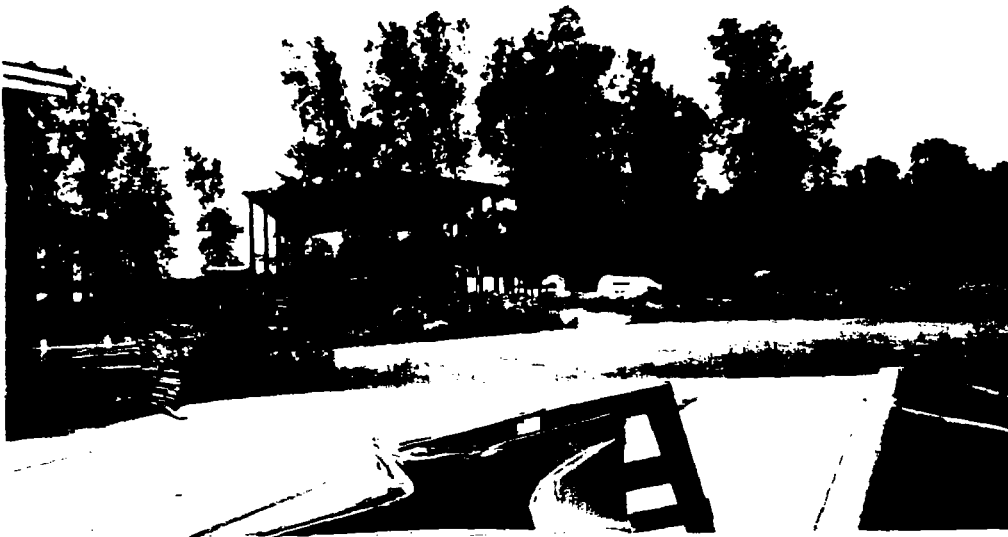
SITE NAME: ORBITRON TDD: T059407003 PAN: EOH1042SAA
DIRECTION: SOUTH DATE: 07/19/94 PHOTOGRAPHER: SW
DESCRIPTION: POLE BARN 1 ON THE SOUTH SIDE OF THE FACILITY. POLE
BARN 2 IS SEEN TO THE LEFT.

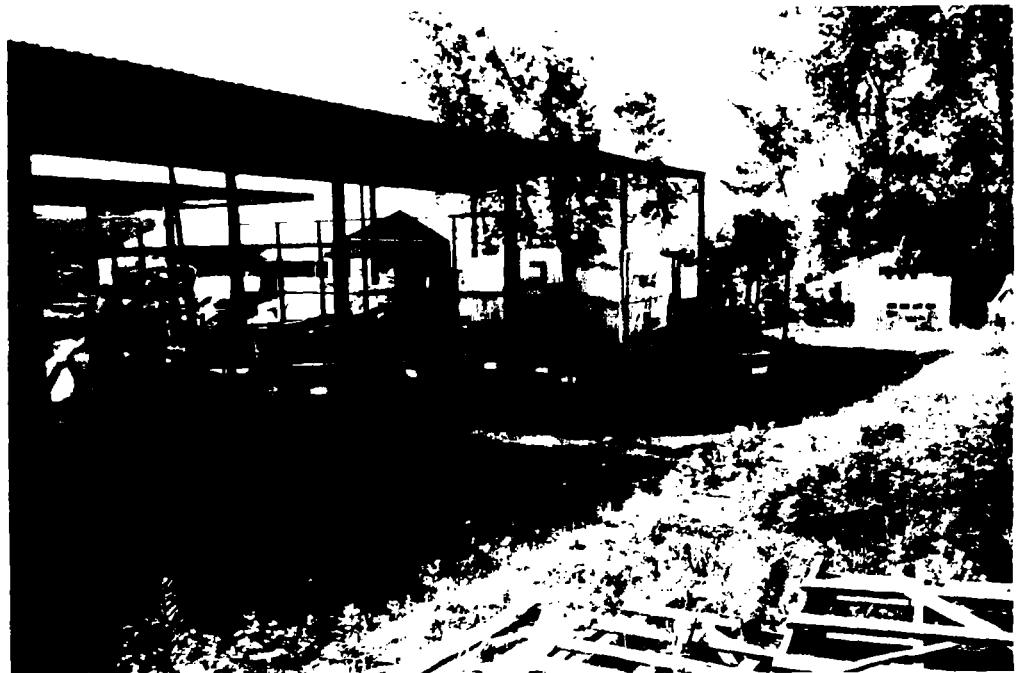
surrounding the location of the June 2, 1994, spill which was investigated by the Delphos FD. Four 85-gallon overpacks and five 55-gallon steel 17-H drums containing the contaminated soil and debris from the spill were among the drums inventoried at this location. The drums were stacked and were unstable. The area to the south of PB1 was cluttered with wood and metal debris, pieces of poly product, and heavy brush. Labels indicated the presence of: isopropyl alcohol, UN 1219; methylethyl ketone (MEK); roof coatings; and other materials labelled "FLAMMABLE". Hand written markings also indicated the presence of used MEK.

SITE NAME: ORBITRON TDD: T059407003 PAN: EOH1042SAA
DIRECTION: SOUTHEAST DATE: 07/19/94 PHOTOGRAPHER: SW
DESCRIPTION: AREA NEAR POLE BARN 1 WHERE ORIGINAL SPILL TOOK
PLACE.

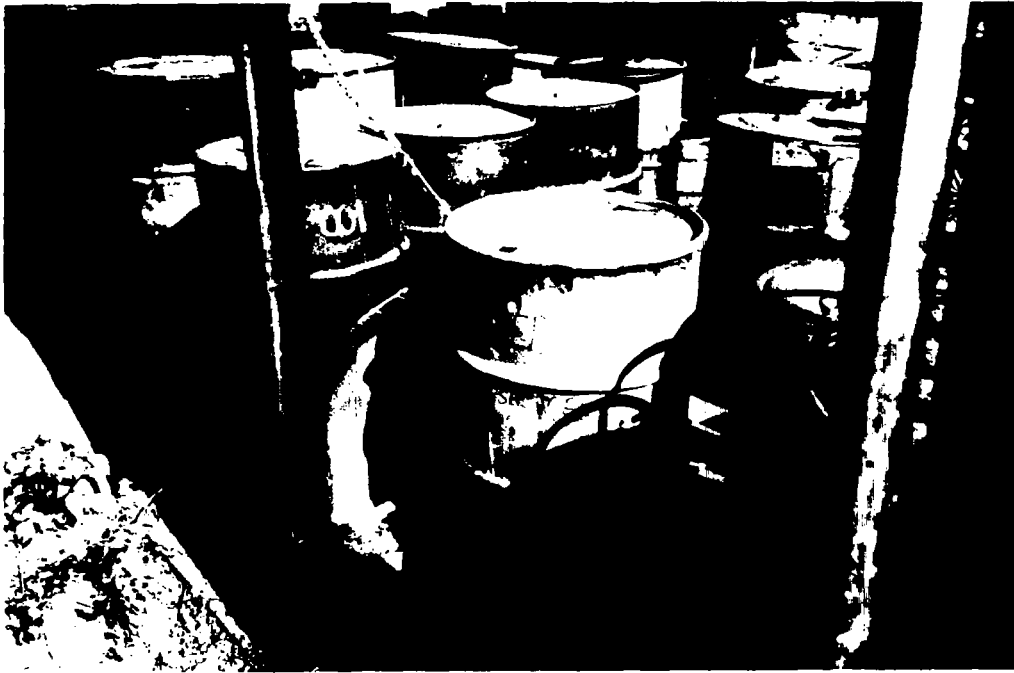
Drum sample OS-001 was a viscous, amber colored liquid collected from a full 55-gallon steel drum. This drum was located in pole barn 1 at the south end of the barn (Figure 4). Drum sample OS-002 was also a viscous, amber liquid from a full 55-gallon steel drum. This drum was also located in pole barn 1 near the drum marked OS-001.

SITE NAME: ORBITRON TDD: T059407003 PAN: EOH1042SAA
DIRECTION: NORTH DATE: 07/19/94 PHOTOGRAPHER: SW
DESCRIPTION: SAMPLE POINT OS-001 AND FULL DRUM MARKED "USED MEK"
UNDER POLE BARN 1. SAMPLE POINT OS-002 IS LOCATED IN THE
BACKGROUND.

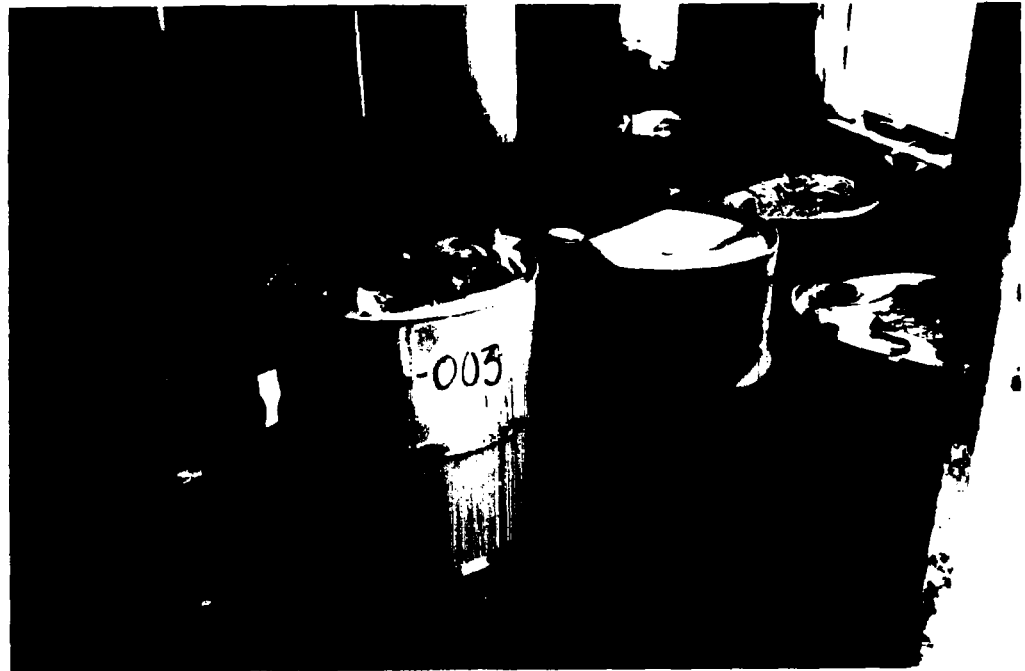
Samples OS-003 thru OS-005A and OS-005B were collected in building 13, the oil house. All were a black liquid collected from three different, full 55-gallon drums. All three of the drums gave readings of >2500 ppm on the PID when held near the drum openings. "Used solvents" was written on the side of drum marked OS-004.

SITE NAME: ORBITRON TDD: T059407003 PAN: EOH1042SAA
DIRECTION: NORTH DATE: 07/19/94 PHOTOGRAPHER: FD
DESCRIPTION: FULL DRUMS OF FLAMMABLE LIQUIDS LOCATED IN BUILDING
13. SAMPLE POINT OS-003 WAS COLLECTED HERE AND ANALYZED FOR
FLASHPOINT AND VOC'S. SAMPLE POINT OS-005 IS TO LEFT OF OS-003.

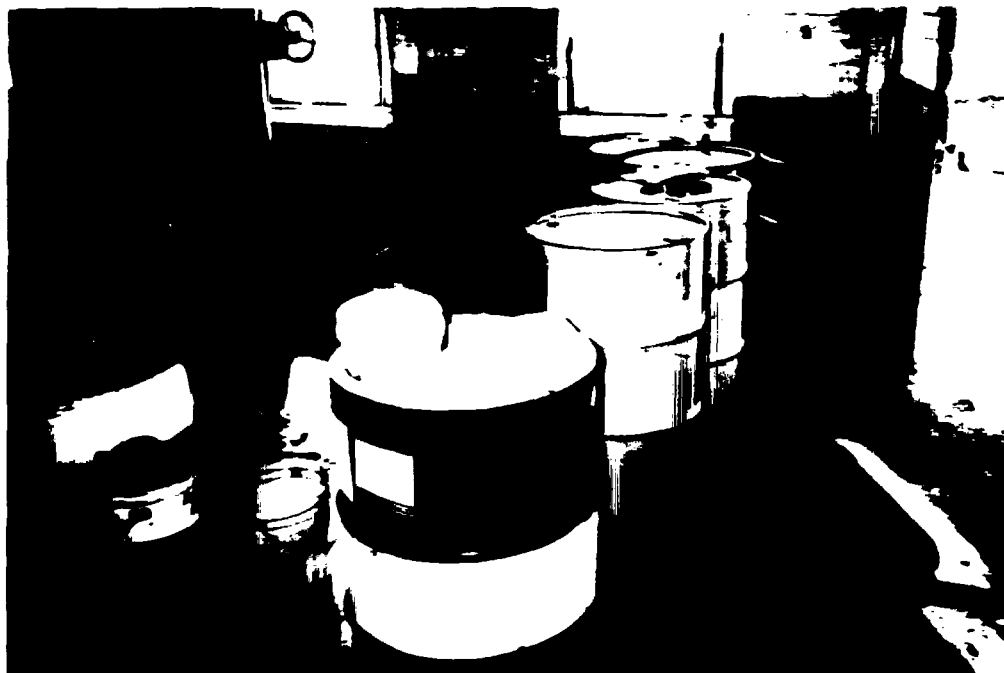
SITE NAME: ORBITRON **TDD: T059407003** **PAN: EOH10428AA**
DIRECTION: EAST **DATE: 07/19/94** **PHOTOGRAPHER: FD**
DESCRIPTION: DRUMS IN BUILDING 13. SAMPLE POINT OS-004 IS LOCATED
IN THE BACKGROUND.

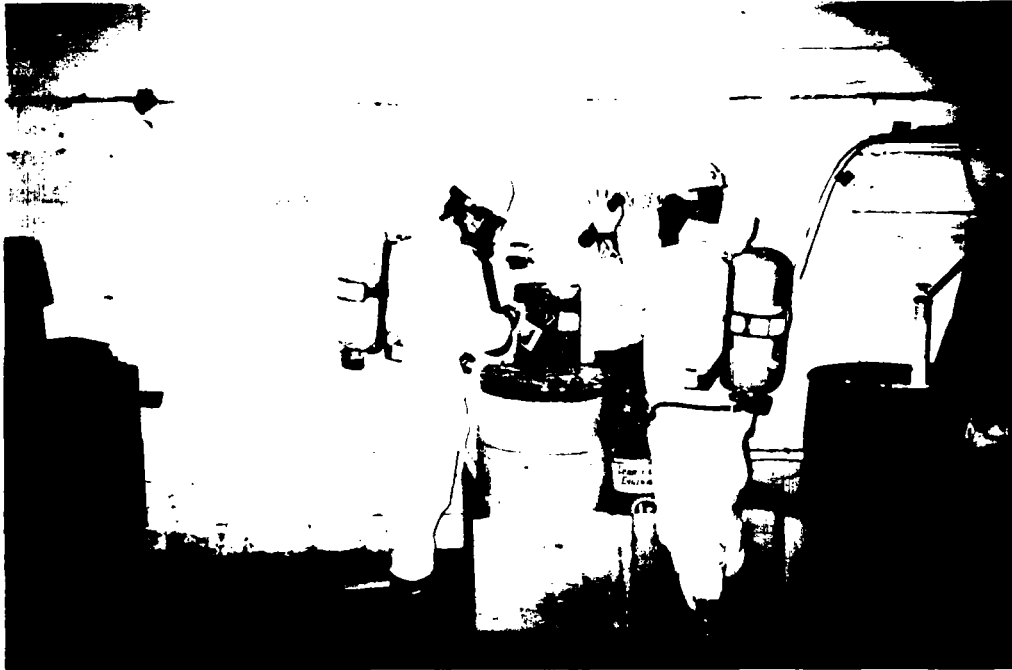
Drum sample OS-006 was a clear, colorless liquid collected from a 55-gallon poly drum. This drum was located in the diked area along the west wall of building 2. The drum was labelled "Cobalt sulfate, potassium bisulfide, H₂O". Material from this drum was field tested for pH which showed a result of 1 to 2 S.U. Drum sample OS-007 was a yellowish, granular solid scraped from the opening of a 5-gallon container. The container was also located in the diked area and labelled "Potassium hydroxide, sodium hydroxide, Alkaline liquid, n.o.s, NA 1719."

SITE NAME: ORBITRON TDD: T059407003 PAN: EOH1042SAA
 DIRECTION: WEST DATE: 07/19/94 PHOTOGRAPHER: SW
 DESCRIPTION: TAT MEMBERS COLLECTING SAMPLE OS-007 FROM CONTAINER
 MARKED "CORROSIVE" IN BUILDING 1. SAMPLE OS-006 WAS COLLECTED FROM
 THE BLUE POLY DRUM TO THE RIGHT.

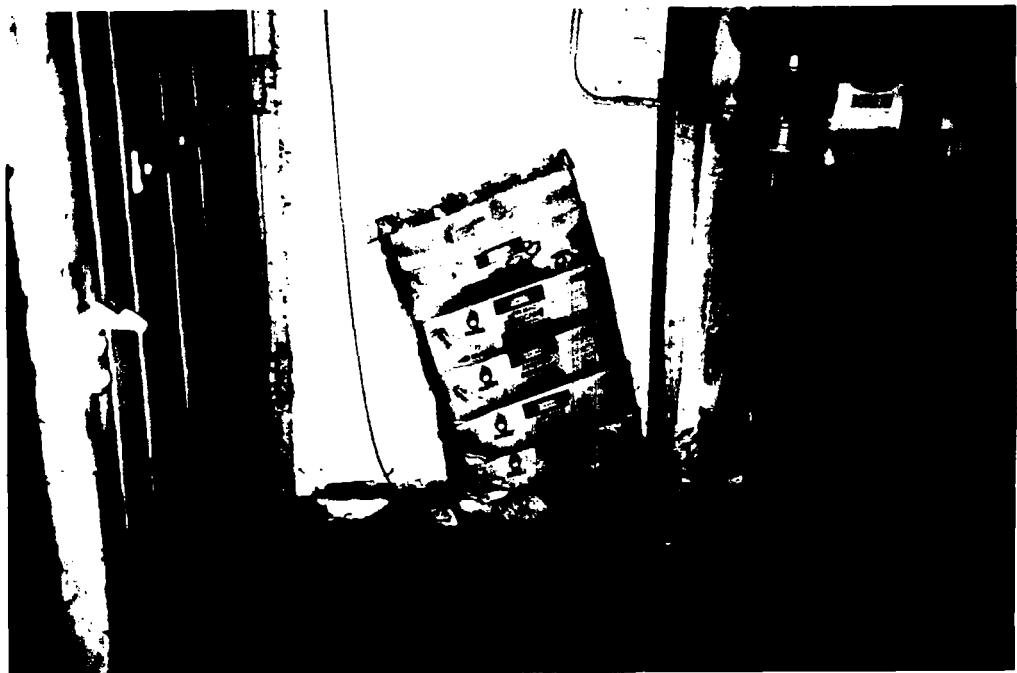
Sample OS-008 was a white, powdery solid collected from the boxes labelled "OXIDIZER", desiccant, in building 10. This sample was field tested by the TAT to determine if it exhibited oxidizer characteristics. After the TAT determined that the material tested positive for oxidizers, OSC Renninger directed that the sample not be sent in for analysis.

SITE NAME: ORBITRON TDD: T059407003 PAN: EOH1042SAA
 DIRECTION: WEST DATE: 07/19/94 PHOTOGRAPHER: SW
 DESCRIPTION: BOXES OF DESICCANT MARKED "OXIDIZER" LOCATED IN
 BUILDING 10. SAMPLE OS-008 WAS COLLECTED AND FIELD TESTED POSITIVE
 FOR OXIDIZING POTENTIAL.

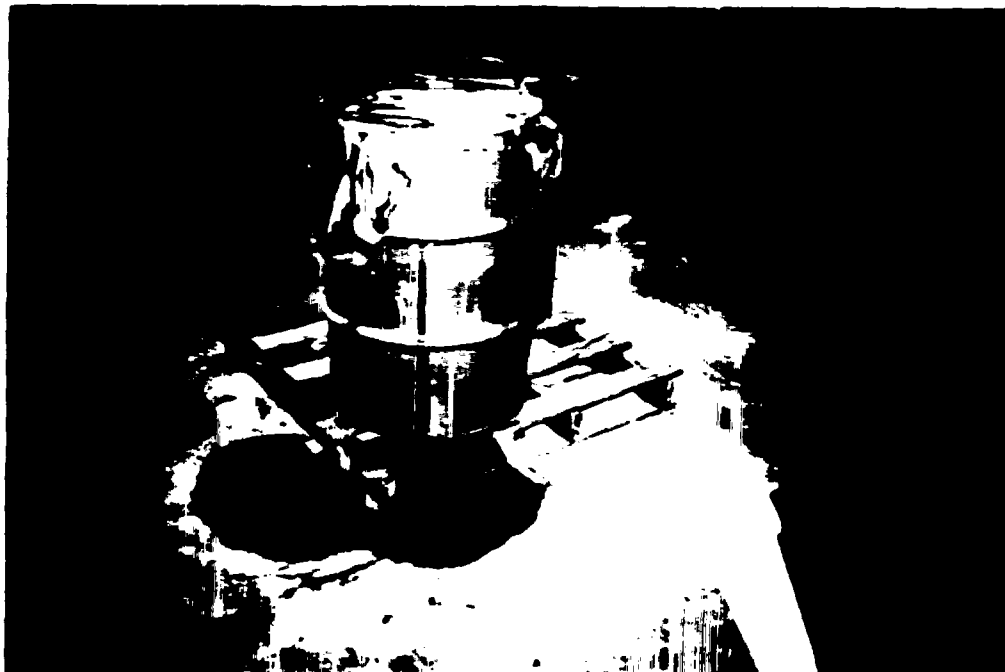
SITE NAME: ORBITRON **TDD: T059407003** **PAN: EOH1042SAA**
DIRECTION: NORTHWEST **DATE: 07/19/94** **PHOTOGRAPHER: SW**
DESCRIPTION: LEAKING DRUMS LOCATED IN BUILDING 10.

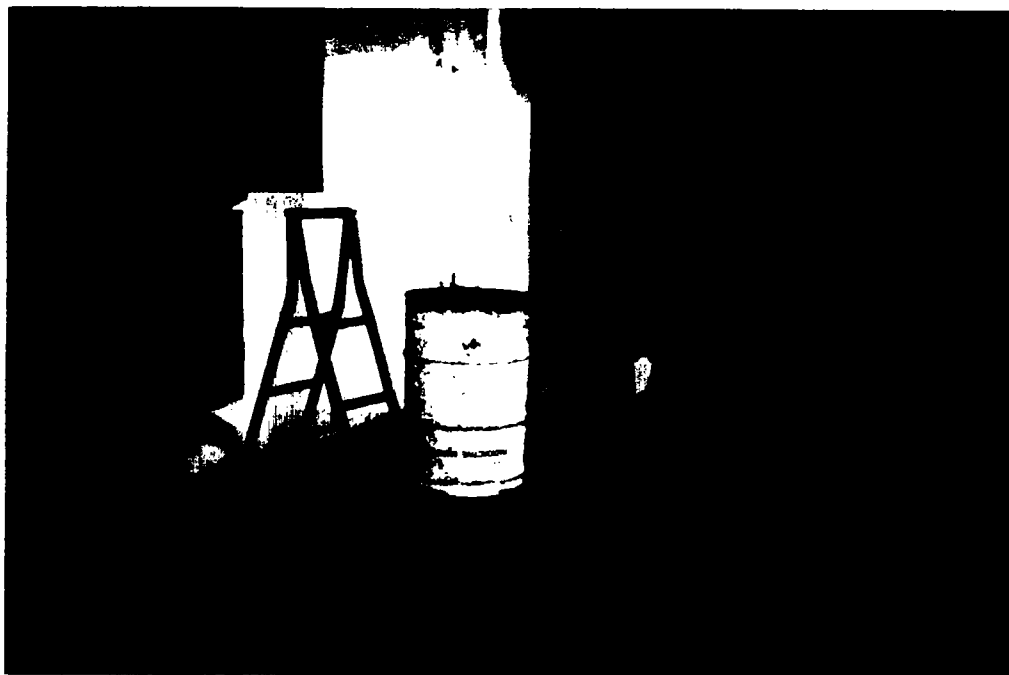
SITE NAME: ORBITRON
DIRECTION: NORTHWEST
DESCRIPTION: EMPTY DRUM
LOCATED IN BUILDING 10.

LABELED "RADIOACTIVE MATERIAL, NOS"

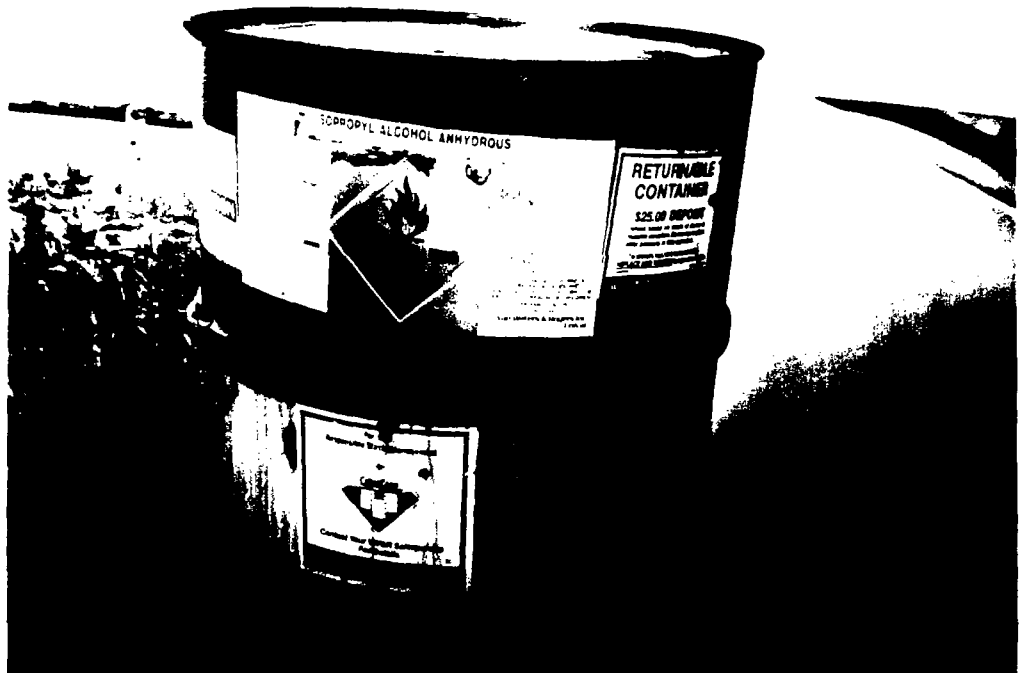
SITE NAME: ORBITRON TDD: T059407003 PAN: EOH1042SAA
DIRECTION: EAST DATE: 07/19/94 PHOTOGRAPHER: SW
DESCRIPTION: FULL DRUM LABELED ISOPROPYL ALCOHOL ANHYDROUS, AND
"FLAMMABLE LIQUID" LOCATED NEAR POLE BARN 2.
